**AVIATION INVESTIGATION REPORT**  
**A03P0268**

**COLLISION WITH DOCK**

**WEST COAST AIRLINES LTD.**  
**DE HAVILAND DHC-6 100 (TWIN OTTER) C-FGQH**  
**VANCOUVER HARBOUR, BRITISH COLUMBIA**  
**03 SEPTEMBER 2003**

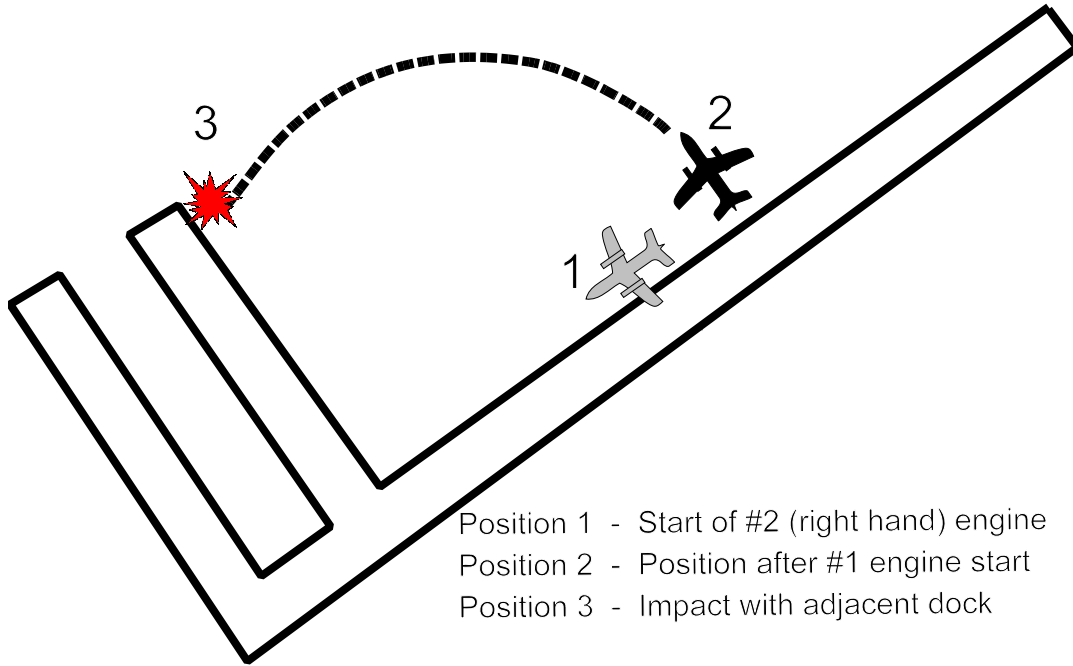
# Appendix A - Dock Layout

As the PIC started to rotate the nose of the aircraft away from the dock, he realized that all the lines had been released, and that the aircraft was adrift. He responded by attempting to hold the aircraft's floats against the dock by using slight reverse on the right-hand engine, while carrying out the start of the left engine. During the left engine start, the aircraft pivoted clockwise to a position about perpendicular with the departure dock (See Appendix A). This rotation was caused by the movement of the left propeller from FEATHER to its operating range.
